Airpark Lagoon Breach Project:

Phase 2

February, 2014

Lake Trail Environmental Consulting

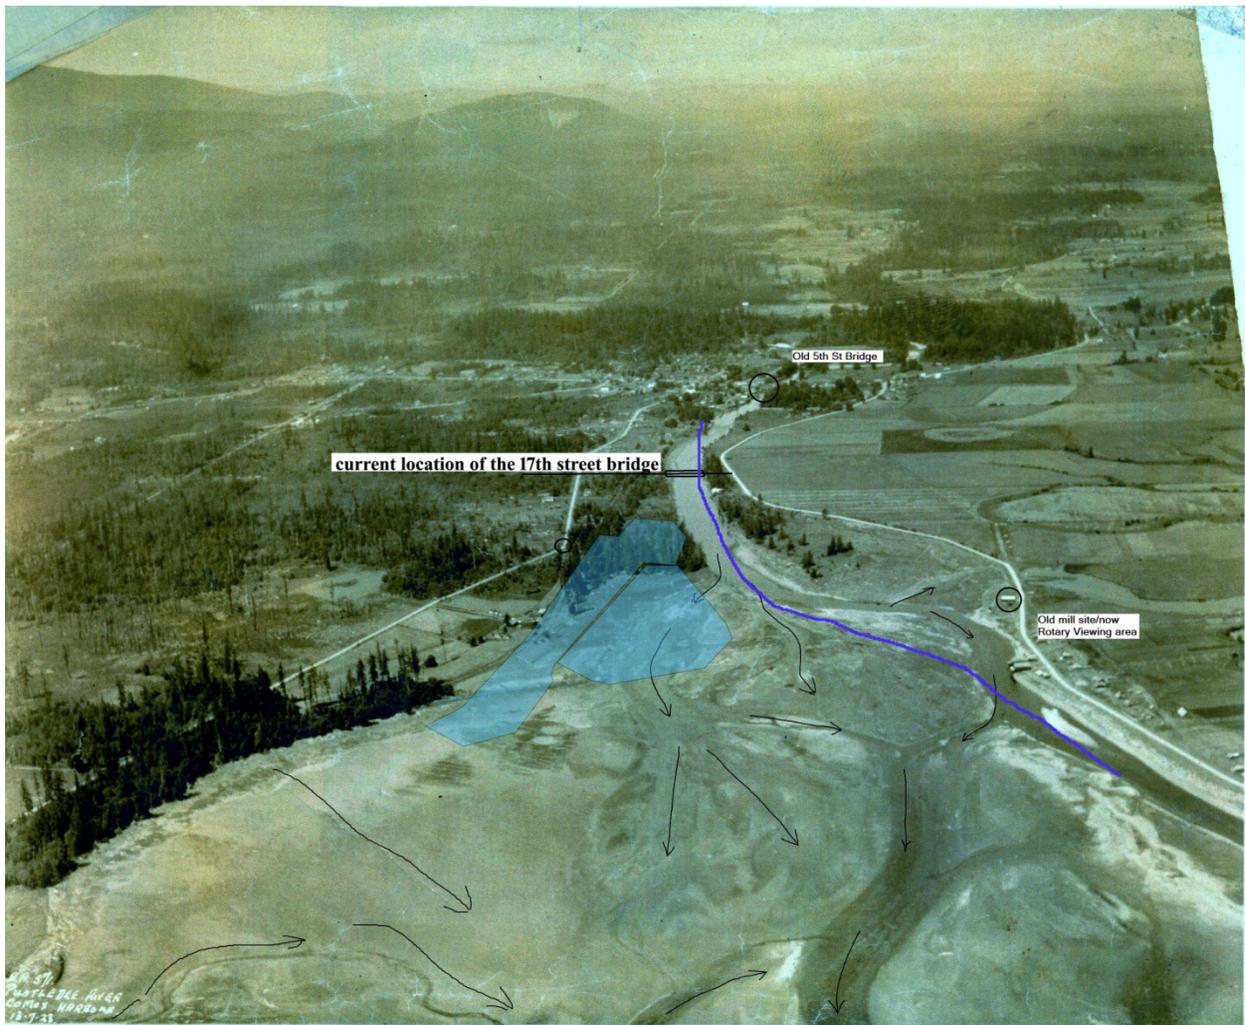
Figure 3: A 1923 oblique view aerial photograph of the project area. Arrows indicate historical flow dynamics, blue line indicates current river alignment according to 2012 Google Earth imagery, and the shaded blue indicate the areas now covered by the runway and the airpark lagoon dike.

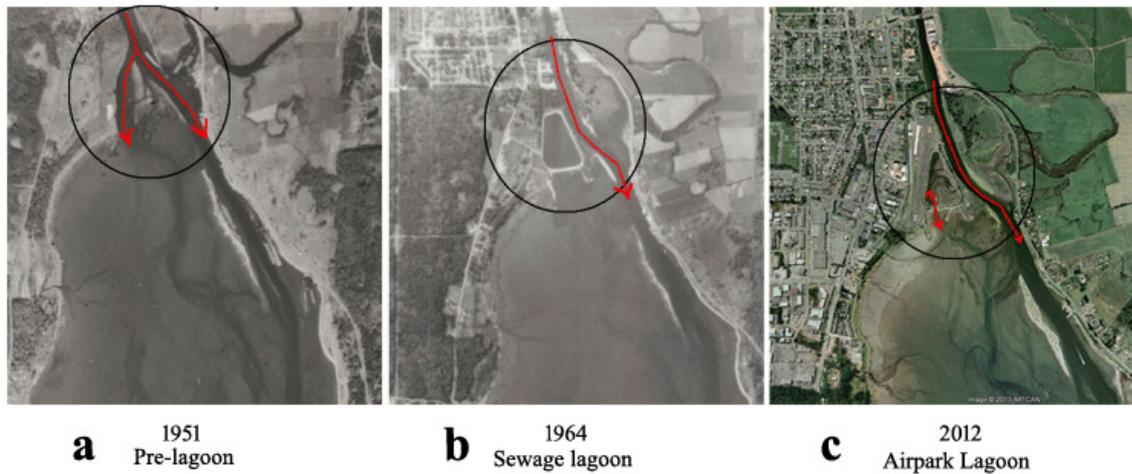
Figure 4: Timeline of modifications to the current Airpark lagoon. Red arrows indicate flow and direction.

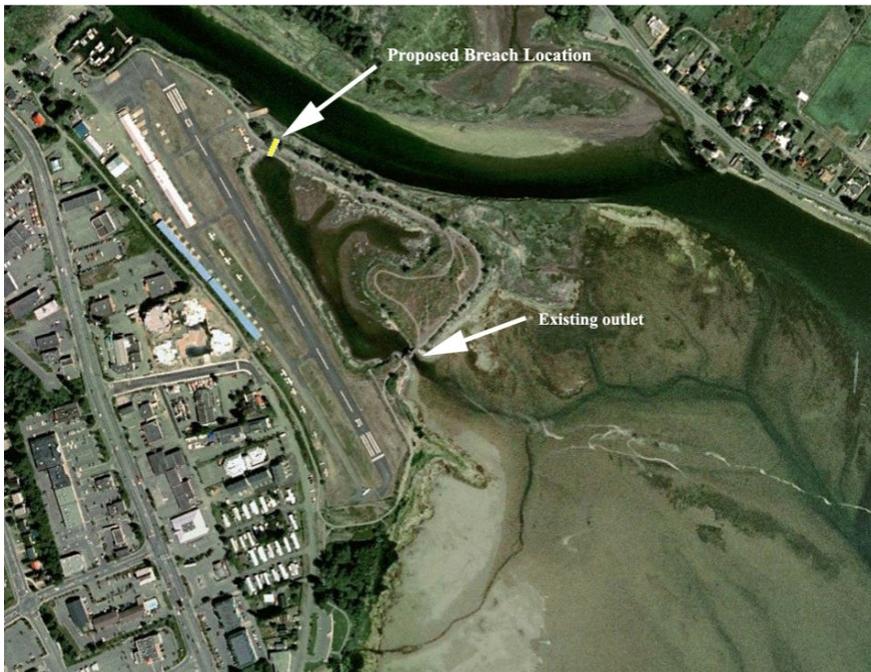
Figure 5: Proposed location of second breach and existing outlet in the Courtenay Airpark lagoon.

Restoration plans involve a simple breach at the top end of the lagoon opposite the current outlet (Figure 5). The second breach will be in the form of a 2.3m concrete box culvert of 20m in length and set at an elevation slightly greater than the outlet to allow water flows from the river into the lagoon at high tides and river discharge. Salvaged salt marsh vegetation will be replanted over the boulder aprons topped by fines and gravels. The project will be monitored for success through ongoing studies of fish and bird use and water quality.

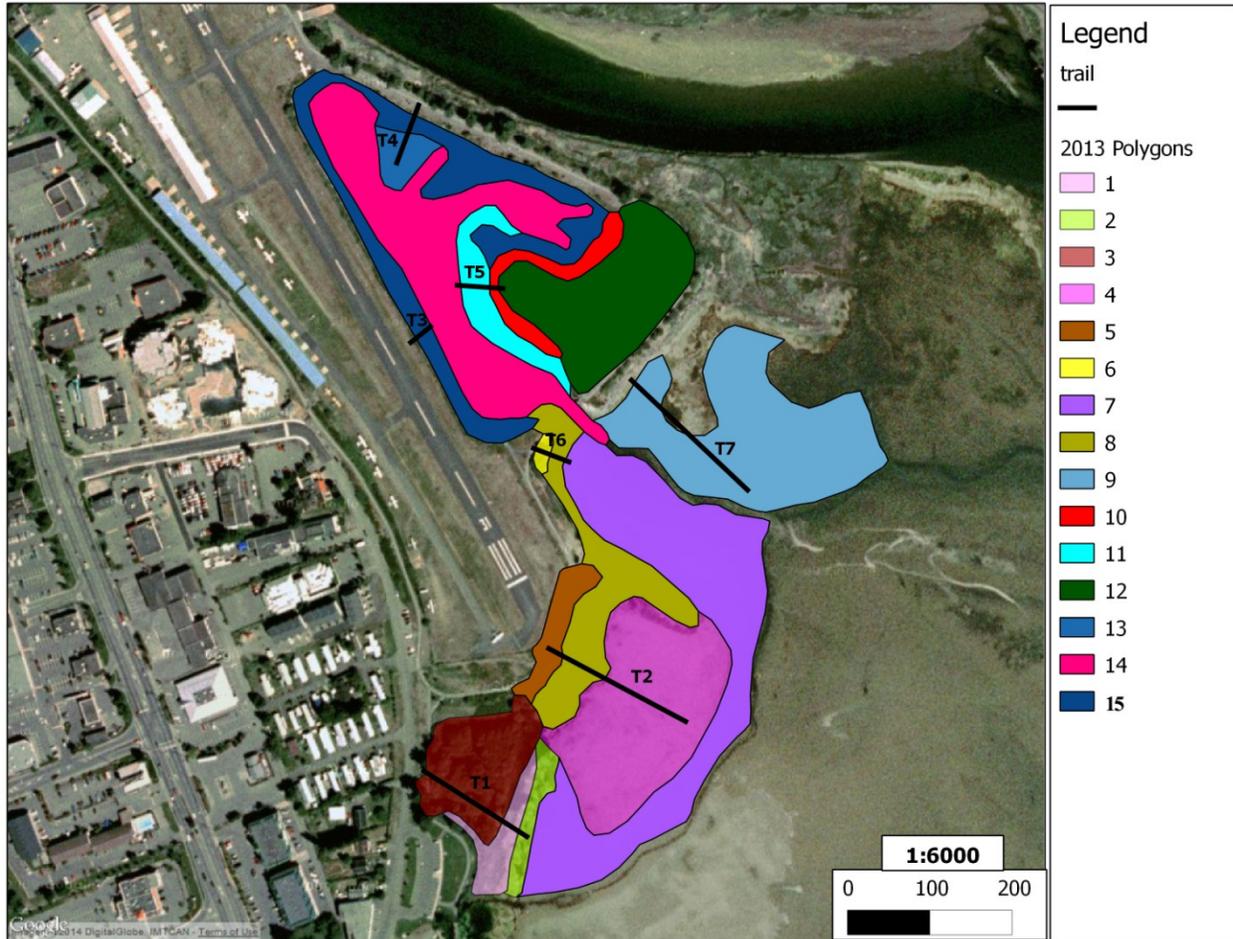
Figure 6: 2013 vegetation assessment polygon and transect (T) locations.

1. Identification of polygons and transects to be assessed based on visual aerial analysis (Figure 6)
2. Field analysis of polygons and transects
3. Compilation of information to excel spreadsheets
4. Translation of field notes into GIS attribute table for mapping
5. Preparation of a map that combined 2010 and 2013 data

Polygon boundaries were defined using aerial photo interpretation refined with ground-truthing, which was carried out by Michele Jones, R.P.Bio, of Mimulus Biological Consultants. To obtain fine-scale information seven transects were assessed from July 22 to 24th, 2013 for banding patterns, including one (Transect 4) that was immediately southeast of the proposed breach. The transects were referenced in the field with measure tape and bisected an area from the riparian zone just above high water to the water's edge; inside the lagoon this was at a chart datum of ~2m, outside it was at ~0m. Transects were assessed using a Trimble GPS to mark the transition between vegetation bands, and bands were characterized based on species present, including dominant and sub-dominant vegetation (expressed as % coverage), other species present, invasive plants, and Species at Risk. All vegetation observations were categorized based on their structure using the system in Table 1. Photos of each site were taken at the time of the assessment and georeferenced. Results were transferred to excel spreadsheet organized by site and zonal banding. Information on dominate species and substrates were applied to an attribute

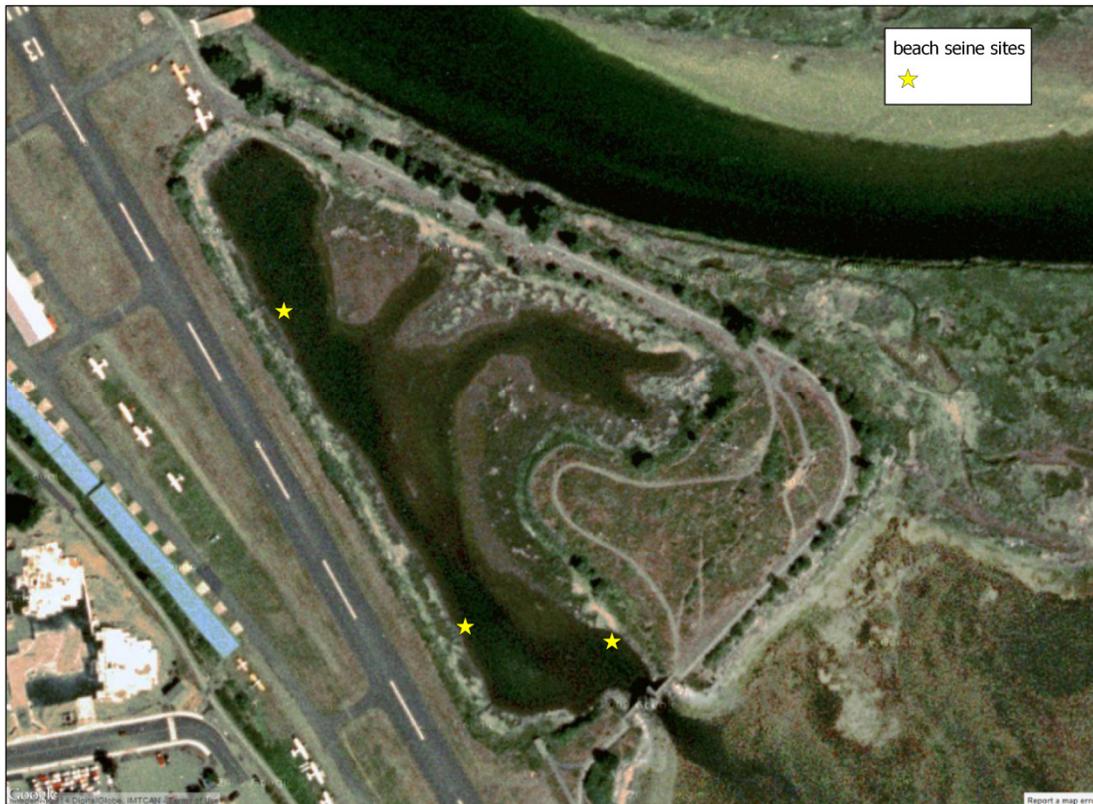
Figure 7: 2013 beach seine sites.

shore crew to retrieve it. The beach seine was fitted with floats and a lead line and made up of three panels of varied mesh sizes: the outside panels were of 3/8" mesh, the inside panel, or bunt, was of 1/8" mesh. The length of the seine was 14m, and the depth at the bunt end was 3m. Attempts were taken at each site to sample the same area, which was approximated at 65m². Sample site locations are provided in Figure 7.

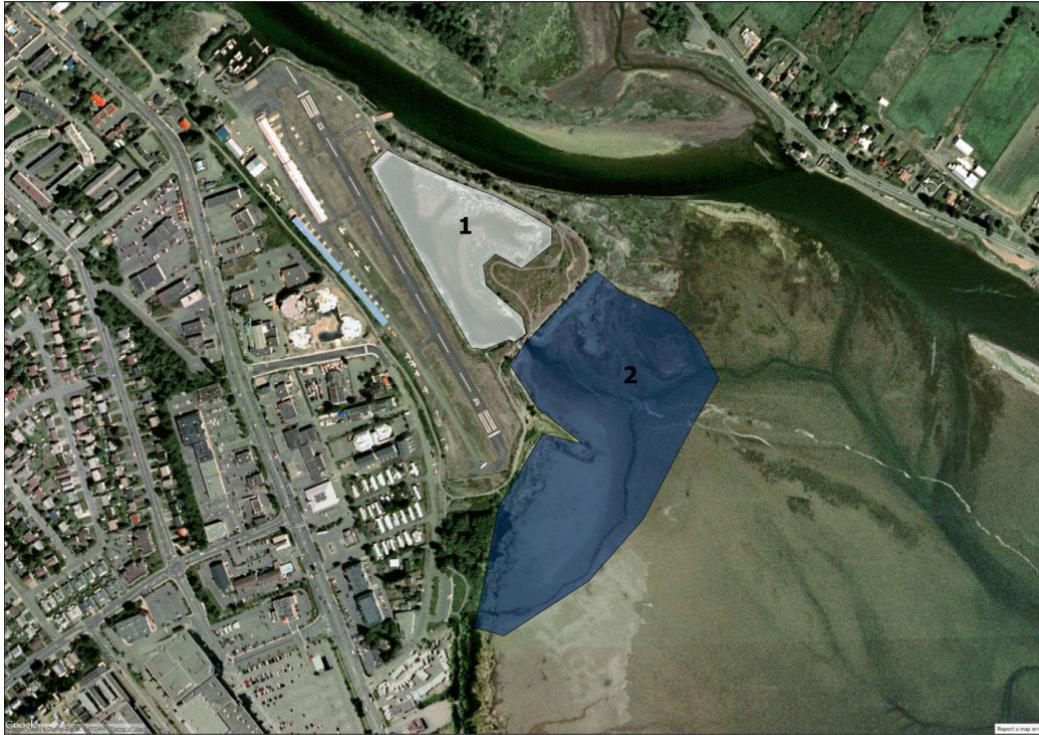
Figure 8: Bird assessment areas 1 (Lagoon) and 2 (Foreshore). Map scale is 1:8000.

one hour during each visit. Bird counts, species and location (lagoon or foreshore) were documented. Figure 8 shows the areas where lagoon and foreshore observations were taken.

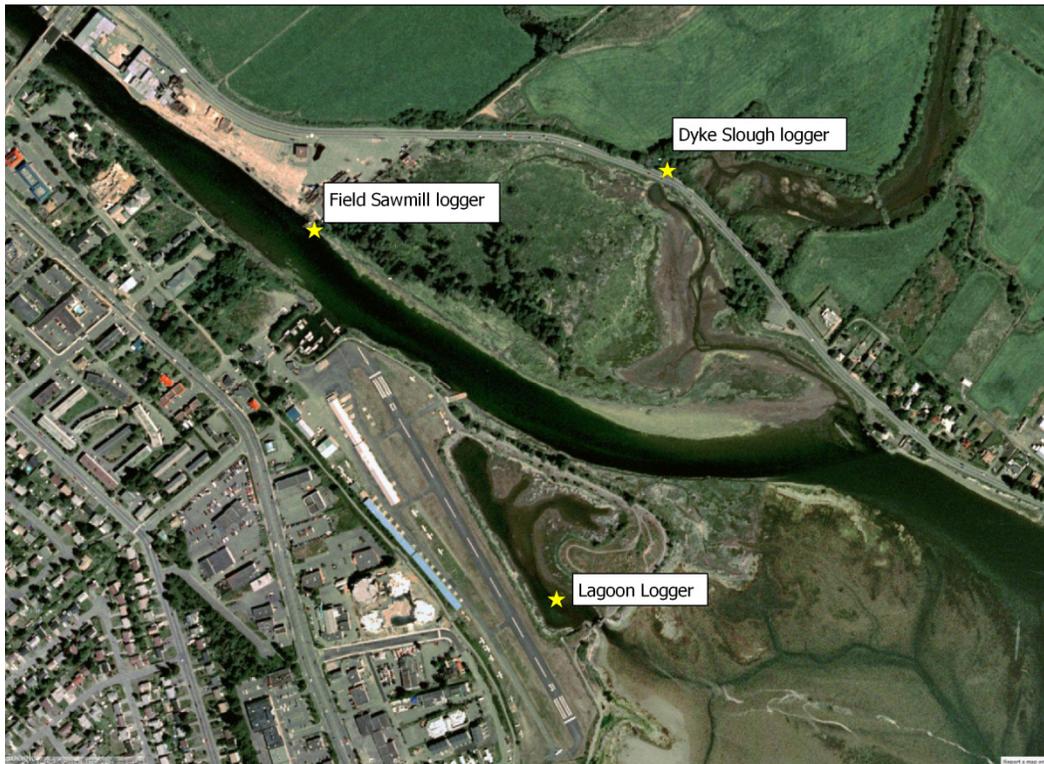
Figure 9: Locations of loggers in the lagoon, river and Dyke Slough (scale 1:9000).

Water level and temperature data for 2013 were available from April 25th to October 3rd for the lagoon site and from July 27th to October 3rd for the river site. Dyke Slough temperature data between April 27th to September 24th were used in the analysis. The lagoon and river loggers collected data at 10 minute intervals, and the Dyke Slough at 15 minute intervals. Sensor depth alternated with the tides, though always remained submerged below the surface. The lagoon logger sensor was set at a geodetic

elevation of -0.271m, the river at -1.192m and the Dyke Slough logger at -0.882m. A map indicating the locations of the three loggers is provided in Figure 9.

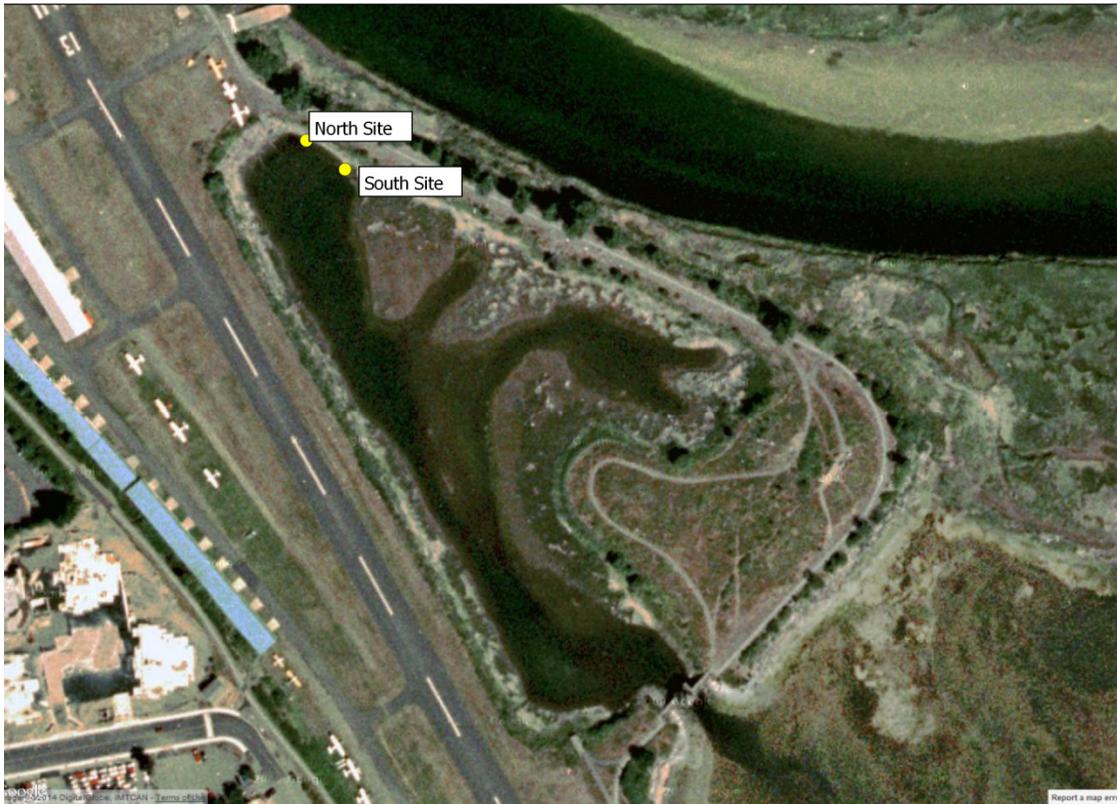
Figure 10: Sediment sampling sites north and south of breach location (scale 1:3000).

Soil sampling of lagoon sediments was done on August 21st, 2013 at 12:45pm during a low tide. Two sediment samples were collected approximately 35m apart within the area of the proposed breach. One sample was taken at the north side of the proposed breach location, the other at the south side (Figure 10). The north sample was taken from a mud substrate with limited vegetation located just above the water line (~2m elevation). The second sample was taken from slightly higher up in elevation on a shallow bench on the south side of the proposed breach location where there was denser growth of salt marsh vegetation. The sampler wore sterilized disposable gloves and used a clean stainless steel trowel to excavate the samples. Soils were collected from a depth of 10-15cm and each sample filled two sterilized 1L amber glass bottles supplied by North Island Labs. Large rocks and vegetation were removed prior to sample collection. Samples were immediately stored in a cooler with icepacks and delivered to North Island Labs within two hours of collection. The samples were then shipped by North Island Labs to their contract lab Exova for analysis.

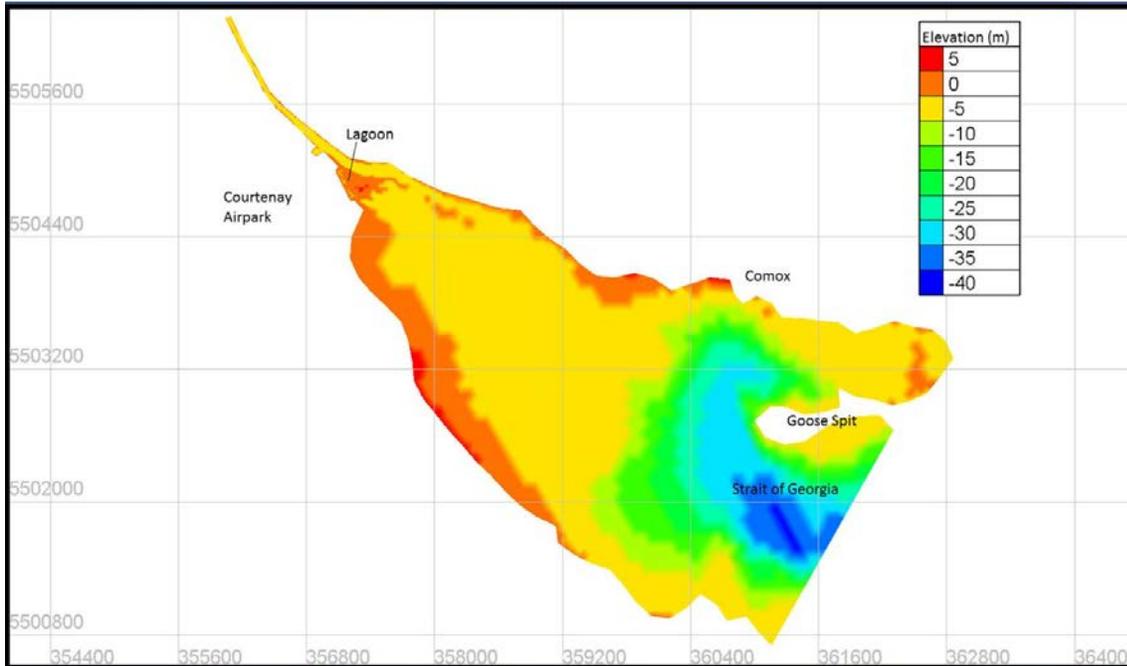
Figure 11: The extents of the TELEMAK 2D model for the lagoon breach project and associated elevations. Map courtesy of Northwest Hydraulic Consultants.

Three scenarios, existing conditions without a breach and 2.44m and 4.27m culverts, were modeled using the TELEMAK-2D. Details on how this model is ran is provided in Consortium (n.d.). The model boundaries extended from the 5th Street Bridge to a line from the Trent River to just outside of Goose Spit (Figure 11). Model inputs included:

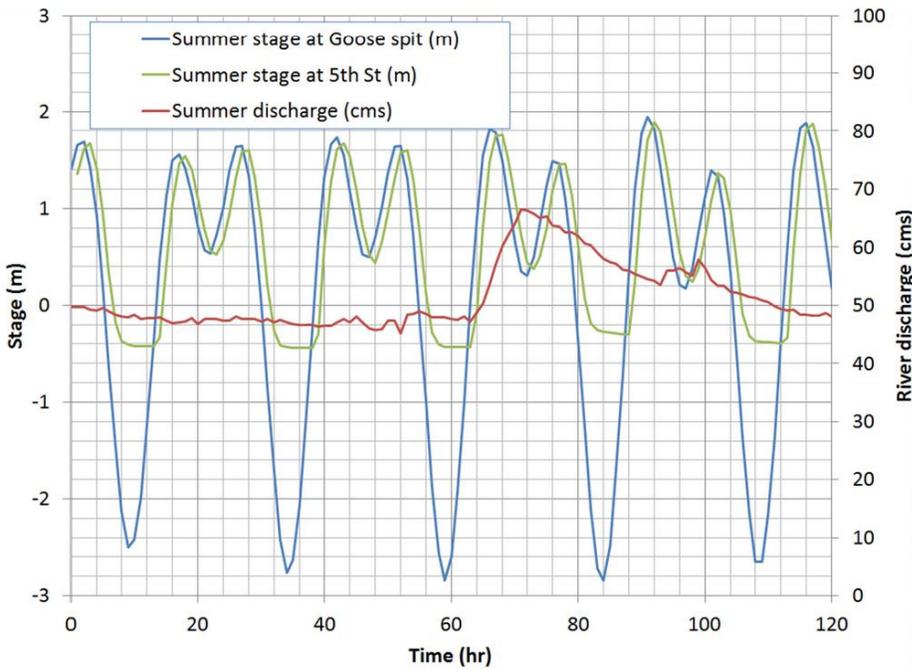
Figure 12: Summer baseline flows from July 1-7th, 2010 used in hydraulic model development. Figure courtesy of Graham Hill of NHC.

The TELEMAC-2D model predicted velocities in the lagoon based on summer and winter conditions representing low, stable flows and peak discharge events, respectively. Hydraulic input for summer conditions came from data collected during average low flow summer conditions that occurred from July 1-7, 2010. Peak discharge conditions utilized data during a period of high flows coinciding with high tide events from January 1-7, 2010 (~400cms river discharge and 5m tides (relative to chart datum). Baseline summer and winter discharges from these periods are provided in Figure 12 and Figure 13, respectively.

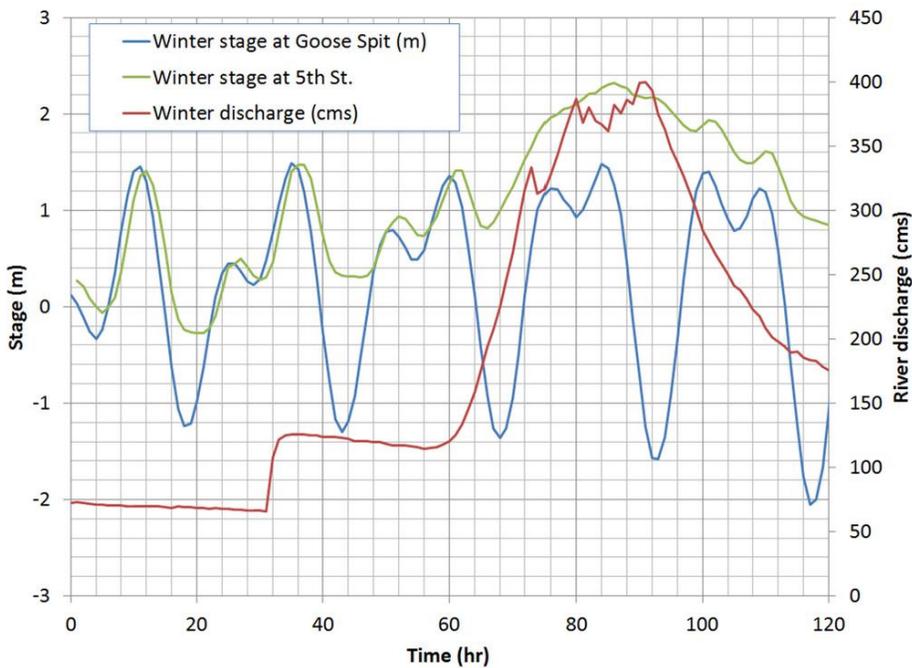
Figure 13: Winter baseline flows from Jan 1-7th, 2010 used in hydraulic model development. Figure courtesy of Graham Hill of NHC.

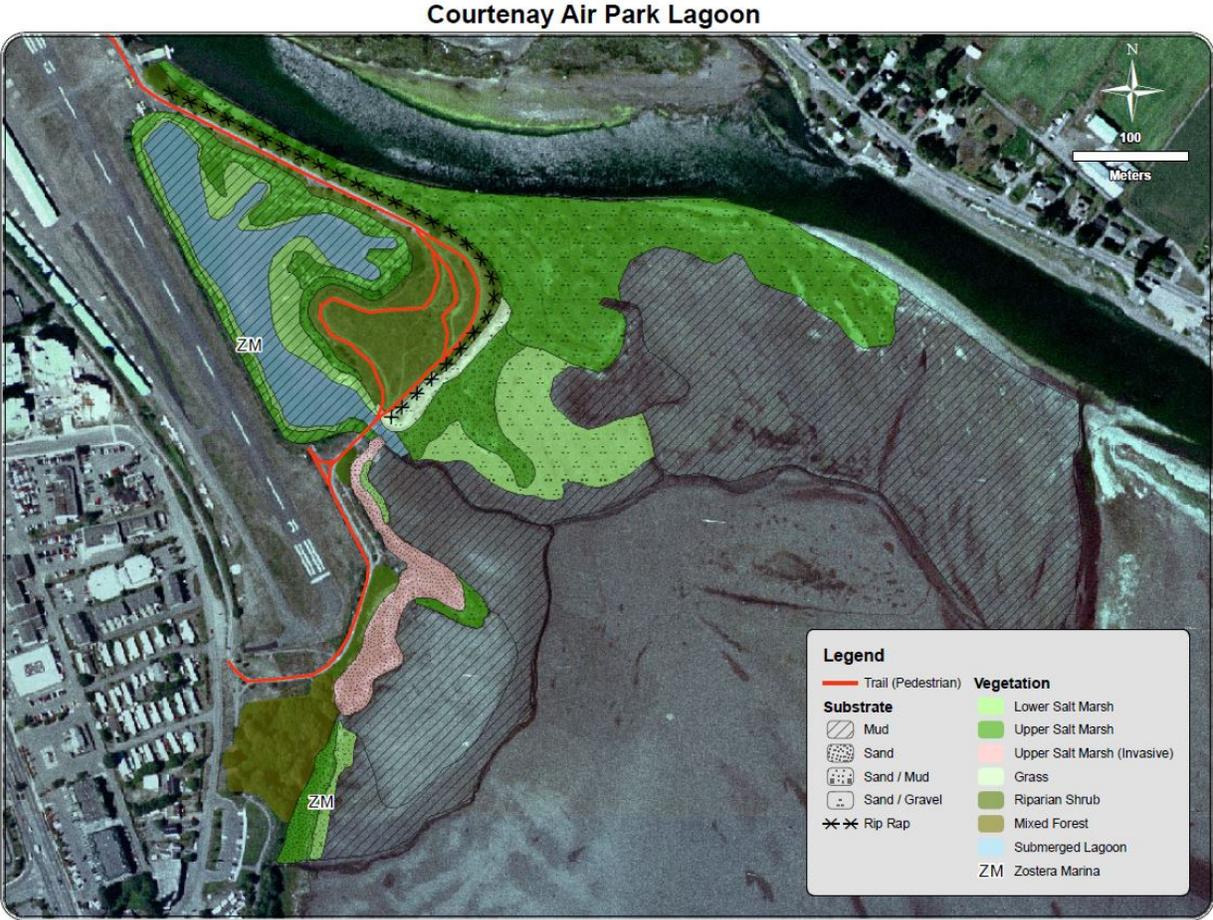
Figure 14: Results of vegetation community mapping.

Figure 14 provides the vegetation community map. Table 2 provides the results of Transect 4, which is located immediately south of the proposed breach location. Photos of Transect 4 near the proposed breach location are provided in Figure 15. A complete list of species and common names encountered during the assessment is provided in Table 3.

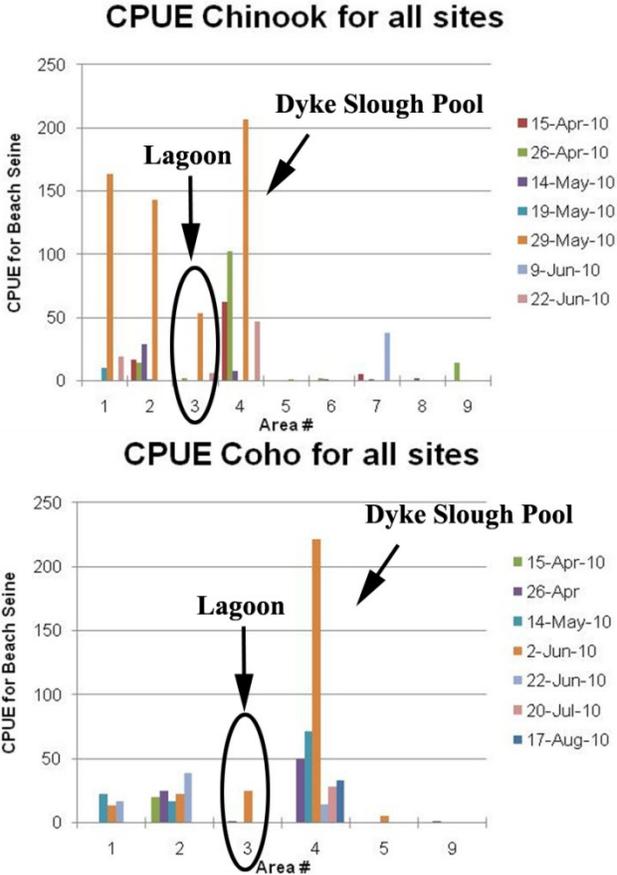
Figure 16: Catch per Unit Effort CPUE for 2010 Chinook and Coho, comparing the Lagoon to the Dyke Slough pool (downstream of Comox Ave. tide gates).

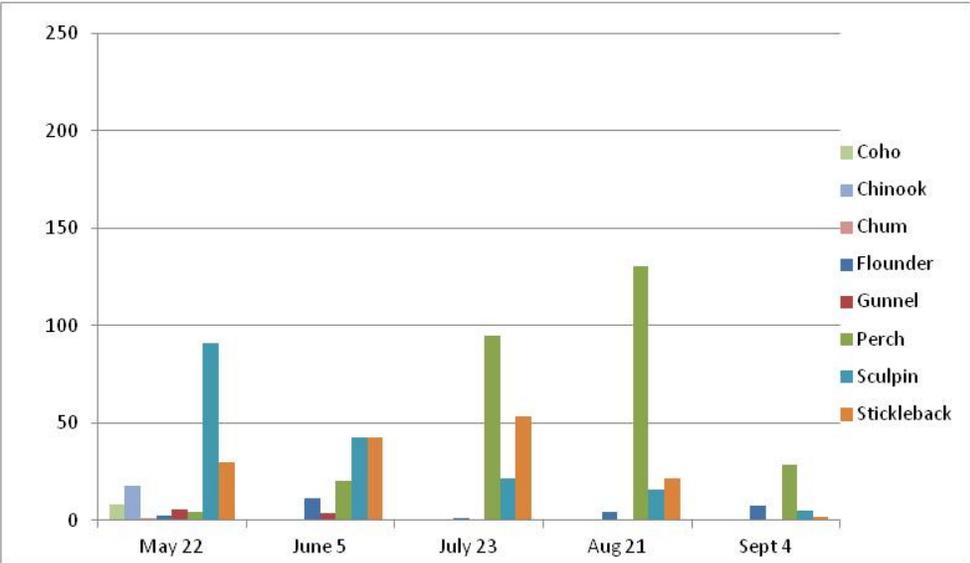
Figure 17: CPUE for all fish species captured in the lagoon in 2013.

During the monthly fish sampling period of May to August in 2010, salmonids were found in the lagoon up to June 3 for Coho salmon and June 23rd for Chinook salmon. In the period from May to August, 2013, salmon captures extended only to June 5 when 1 Chinook was captured, though most were captured in the first sampling session, May 22. Juvenile Coho and chum salmon were also captured on May 22. Other species observed throughout the sampling period included flounder, gunnel, perch, pipefish, sculpin, shrimp and stickleback. Figure 16, Appendix 1 provides a summary of Coho and Chinook captures in 2010 compared to other sites sampled at the time. Figure 17 provides an overall capture of all fish species in the lagoon during the summer 2013 sampling period.

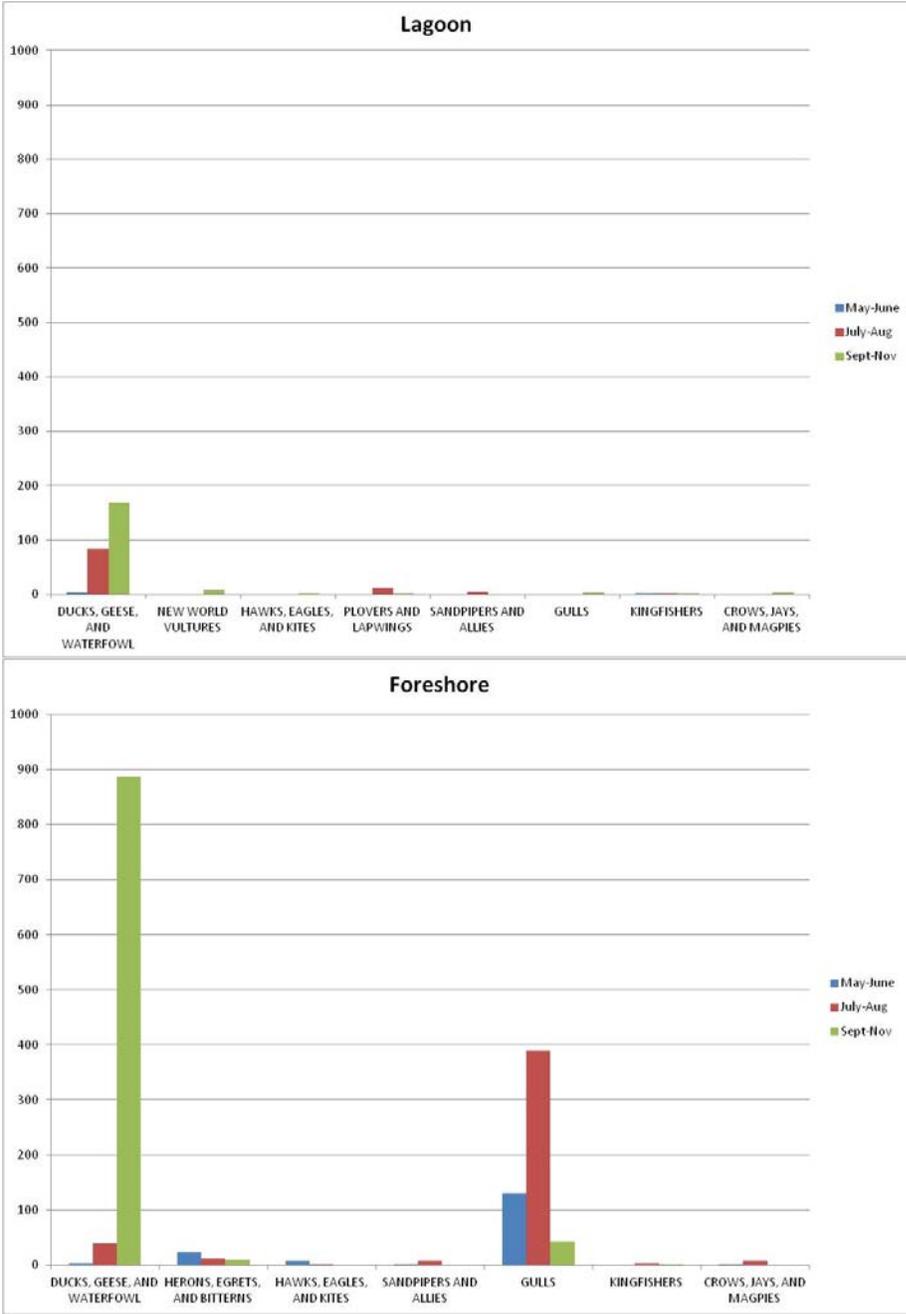
Figure 18: Comparison of bird counts in the lagoon and foreshore over the spring (blue), summer (red) and fall (green).

The foreshore area had more bird observations than the lagoon over the 2013 May to November assessment period. Bird use in both areas was generally low through the summer months (Figure 18). More waterfowl were observed in the lagoon than the foreshore in the summer, though numbers in the

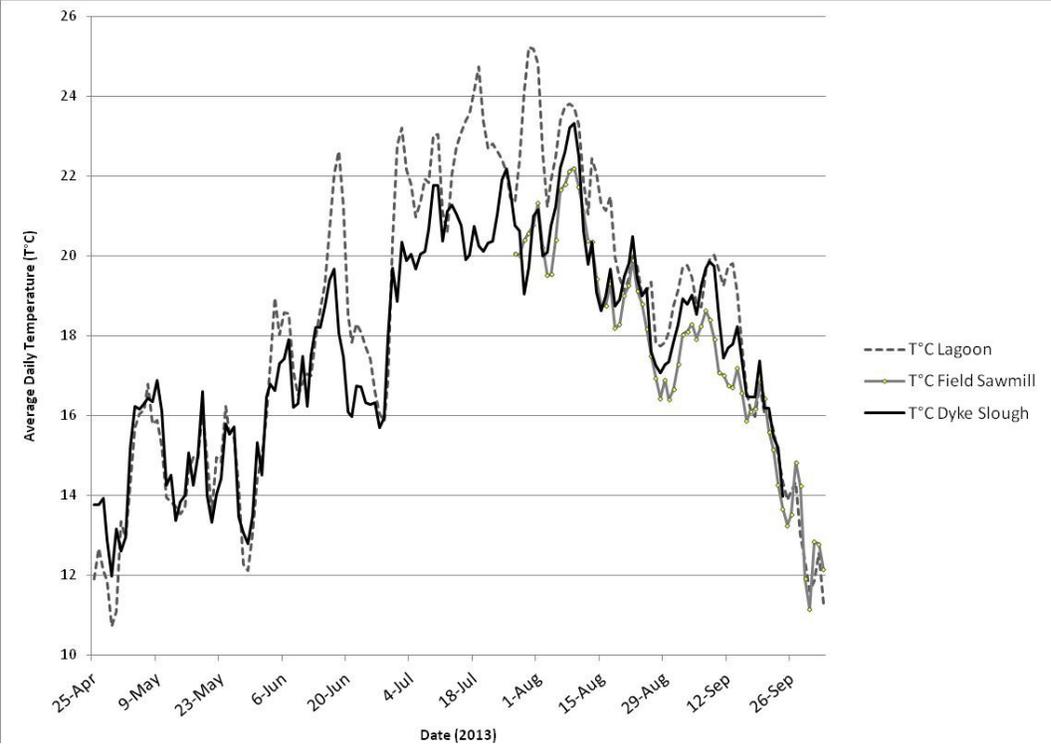
Figure 19: Average daily temperatures from spring to fall for the lagoon and Dyke Slough, and from summer to fall in the river.

Water temperature at all three stations is displayed in Figure 19 for April to October, and a close-up of June to September temperatures is in Figure 20. A box plot of this same period for all sites is in Figure 21, and the relative frequency of lagoon temperatures for each month is in Figure 22.

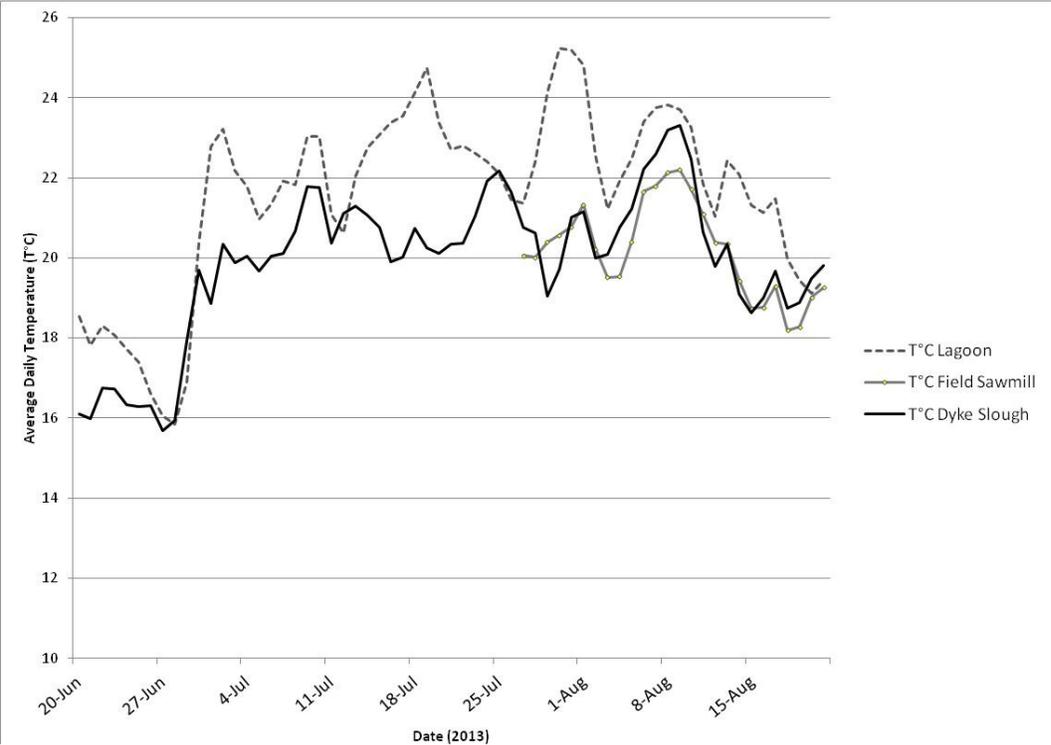
Figure 20: A close up of average daily temperatures in the lagoon, river and Dyke Slough for the summer months.

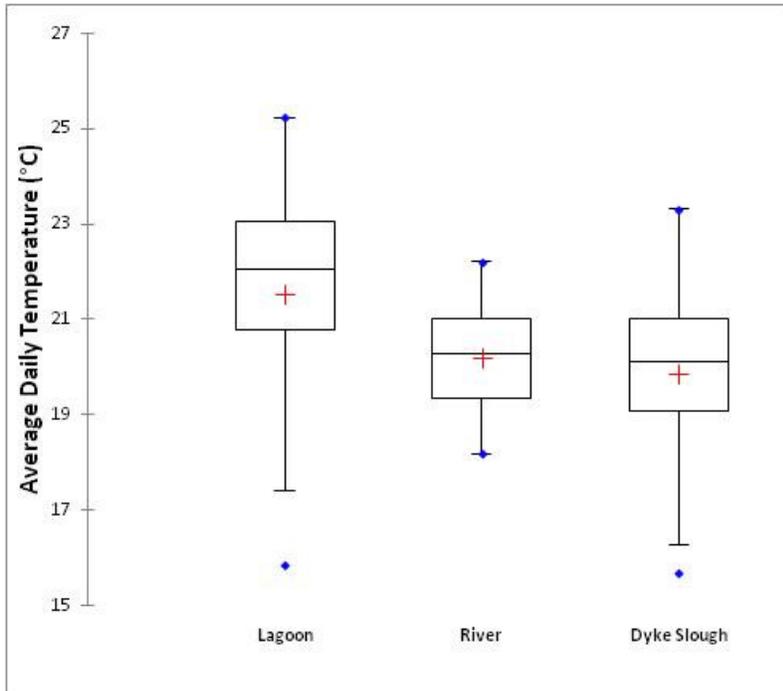
Figure 21: Boxplot of average daily temperatures in lagoon, river and Dyke Slough from June 20th to August 21st, 2013. The box boundaries indicate the upper and lower 25% quartiles. The whiskers indicate the maximum and minimum values, the blue rhombuses indicate the outliers, and the red cross the mean values. The line bisecting each box indicates median values.

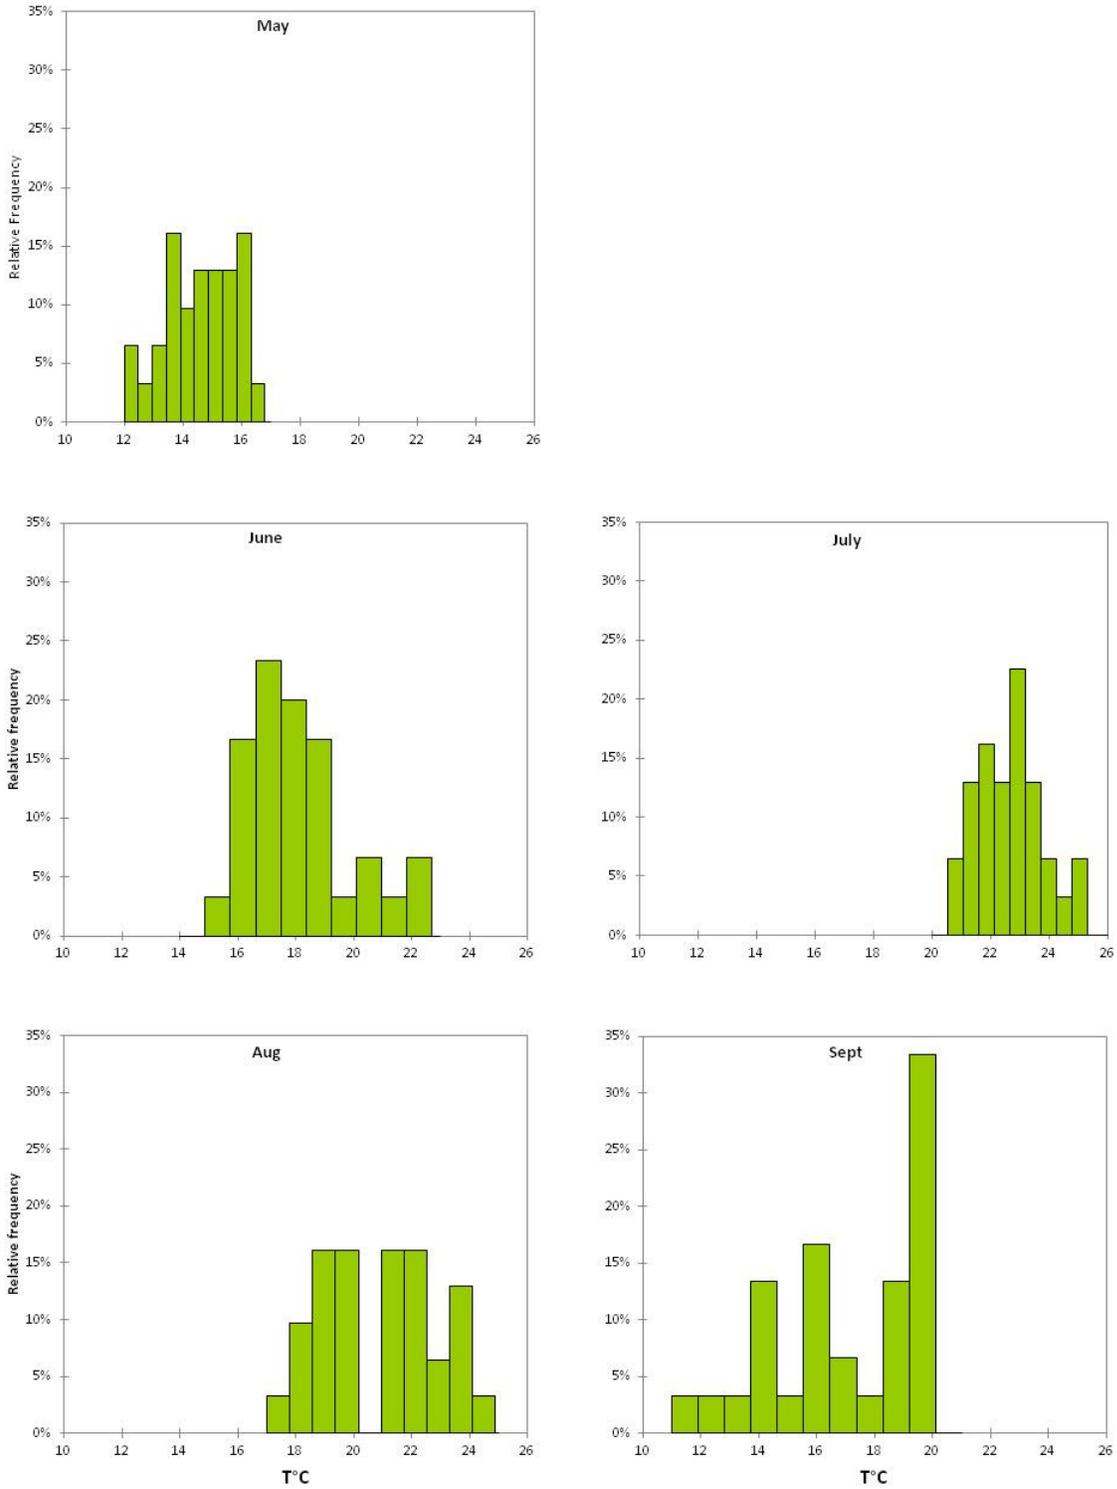
Figure 22: Histogram showing the range in water temperatures in the lagoon, and their relative frequencies throughout each month from May to September.

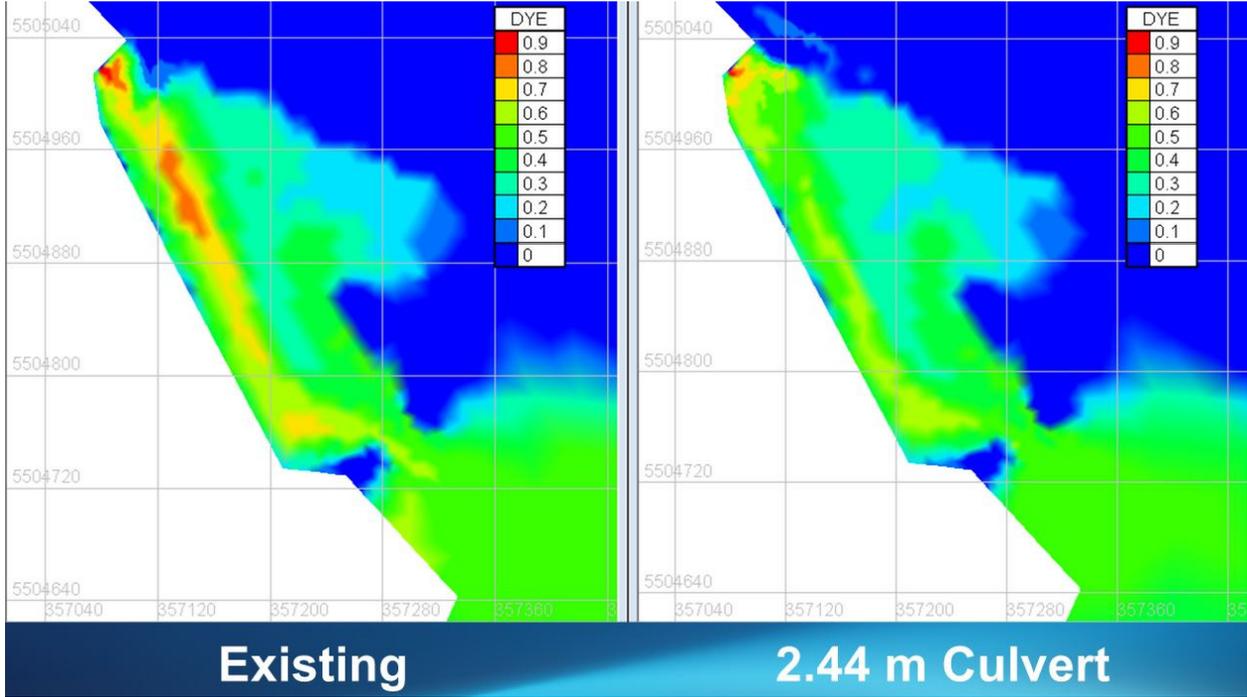
Figure 23: Dye test comparing dilution after 3 hours of existing lagoon conditions and the addition of a 2.4m culvert breach. Figure courtesy of Graham Hill of NHC.

A visual map of the dye test indicated a 2.4m breach will have substantial improvements in flushing rates after only 3 hours compared with the existing single breach (Figure 23). Given summer baseline conditions, the 2.4m culvert is projected to flush >70% of the lagoon in 10 hours compared to 34 hours without the breach, and >80% after 34 hours compared to 59 hours without (Figure 25). A map of

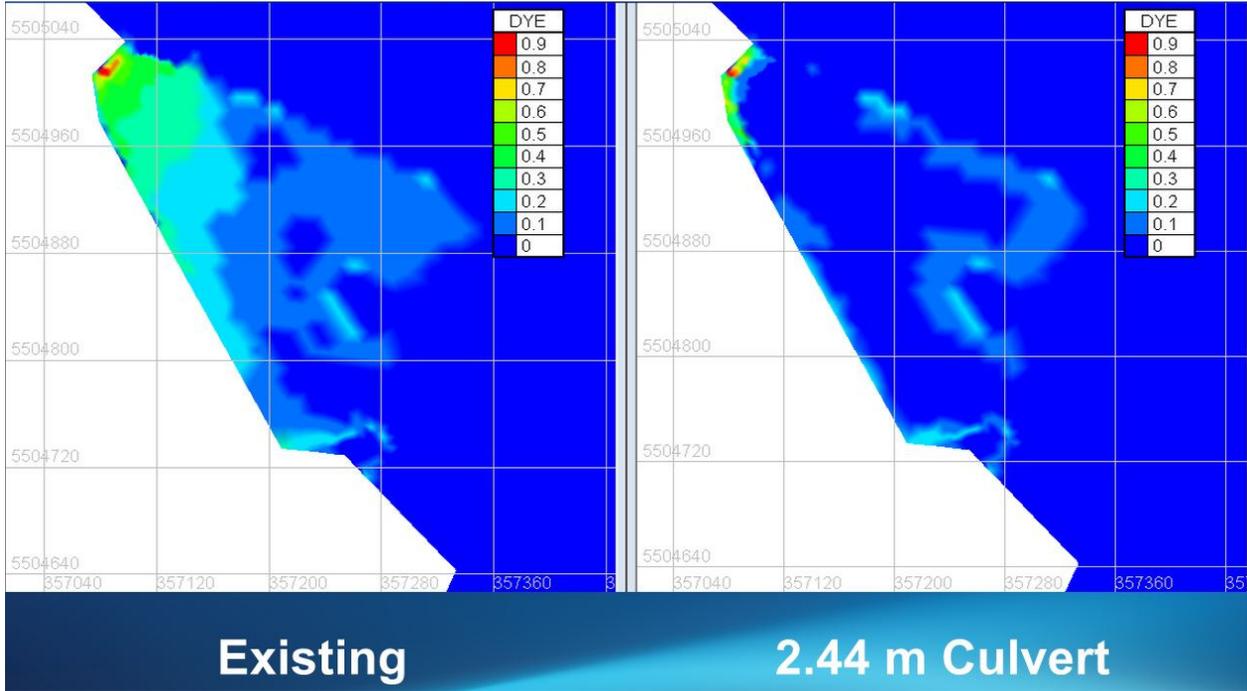
Figure 24: Dye test comparing dilution after 48 hours of existing lagoon conditions and the addition of a 2.4m culvert breach. Figure courtesy of Graham Hill of NHC.

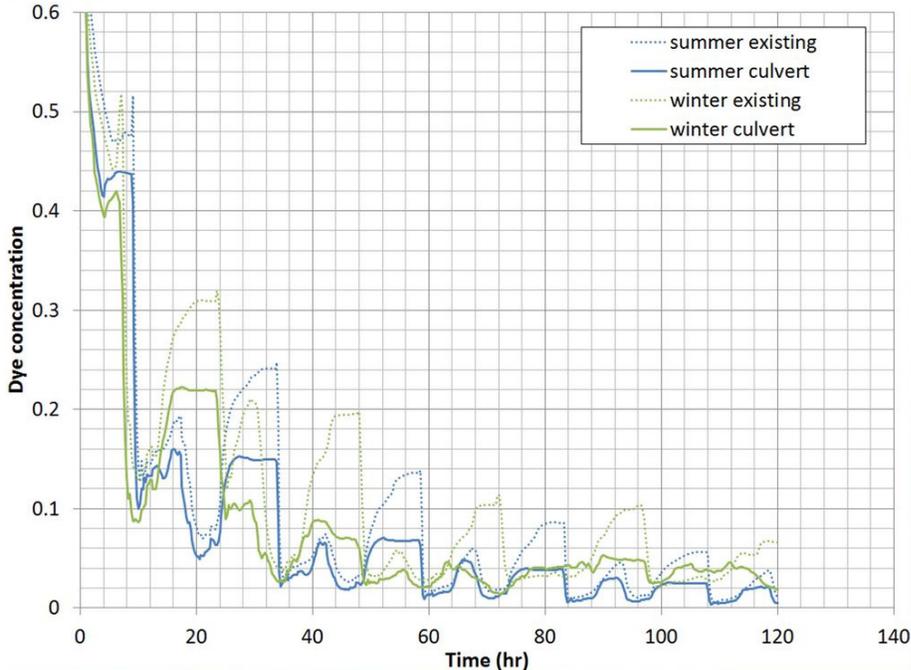
Figure 25: Dye test comparing dilution over time of existing lagoon conditions and the addition of a 2.4m culvert breach over winter and summer baseline flows. Figure courtesy of Graham Hill of NHC.

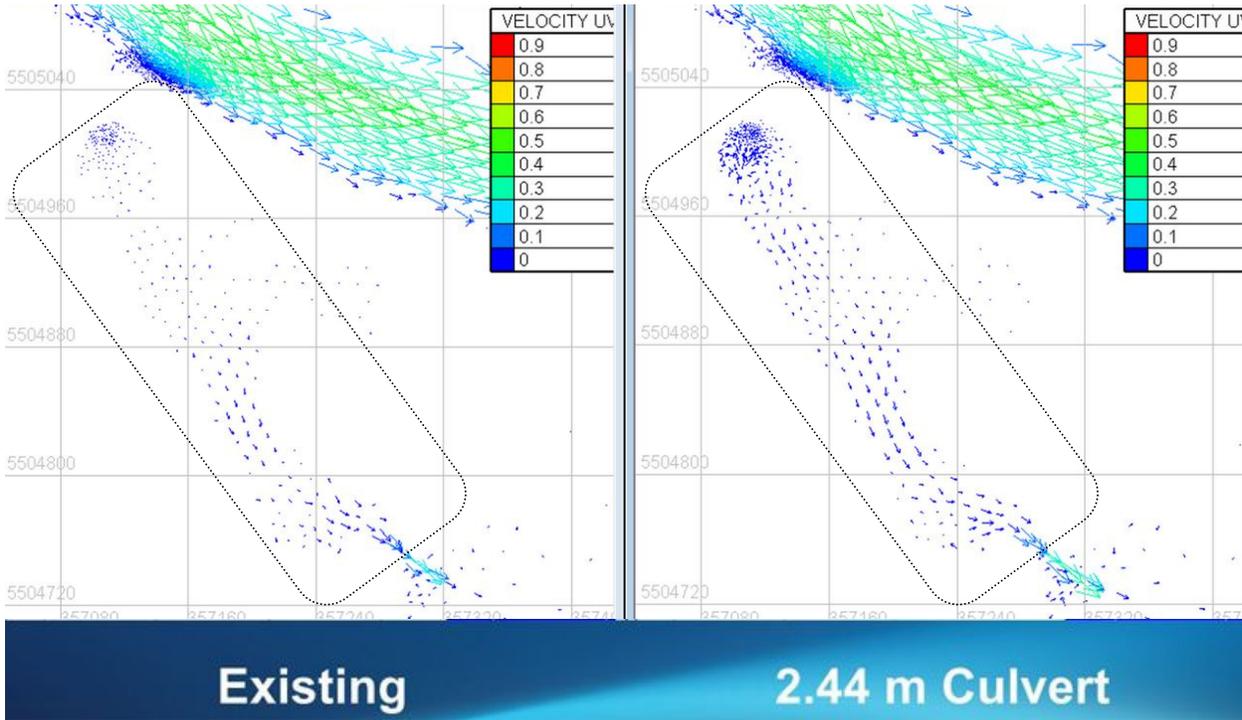
Figure 26: Velocity comparison of 2.4m culvert and exiting single breach in lagoon during a low tide and baseline summer flows. Area inside rectangles indicate lagoon location, adjacent area is river channel. Figure courtesy of Graham Hill of NHC.

velocity vectors also indicated a greater concentration of surface water movement through the lagoon with the 2.4m culvert (Figure 26).

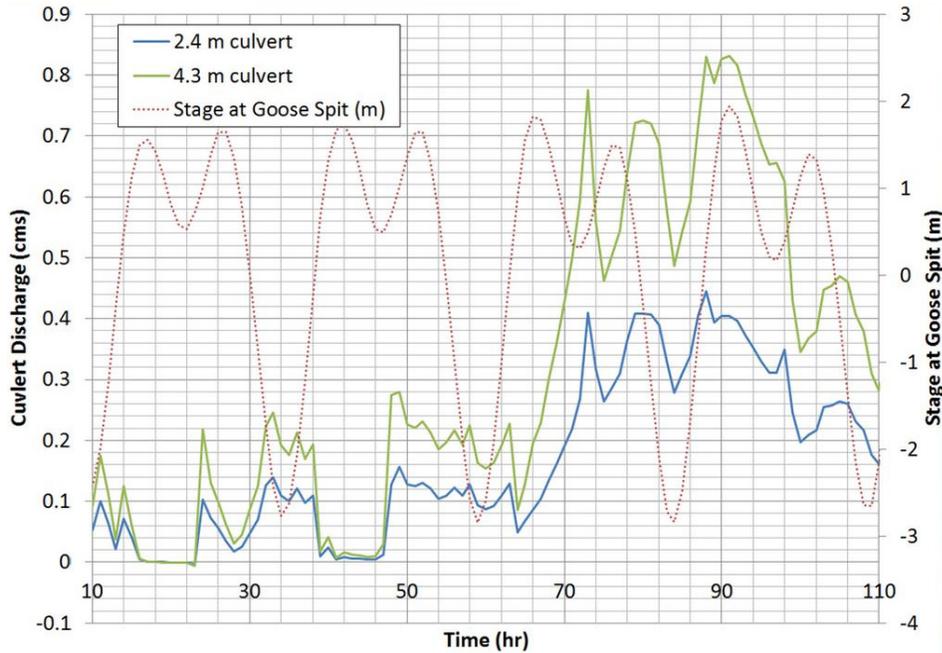
Figure 27: Comparison of culvert discharge through 2.4 and 4.3 culvert options for proposed breach given winter baseline flows. Figure courtesy of Graham Hill of NHC.
