Airpark Lagoon Breach Project:

Phase 2

February, 2014

Lake Trail Environmental Consulting

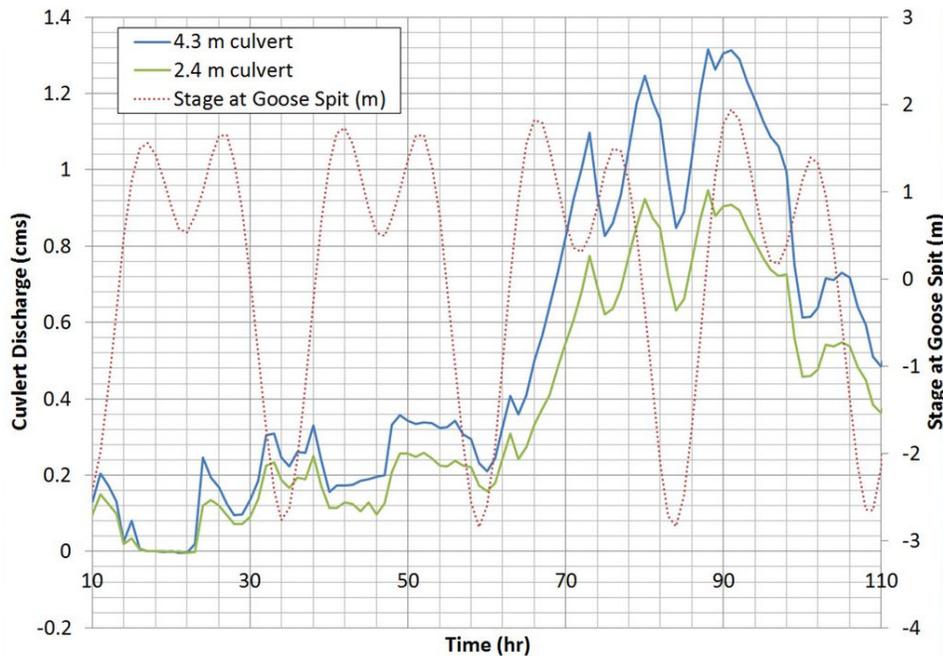
Figure 28: Comparison of culvert discharge through 2.4 and 4.3 culvert options for proposed breach during high flow conditions. Figure courtesy of Graham Hill of NHC.

The hydraulic model indicated that a 2.4m breach would increase flushing rates, with the redirecting of <1 cms during high flow conditions from the river through the culvert (Figure 28).

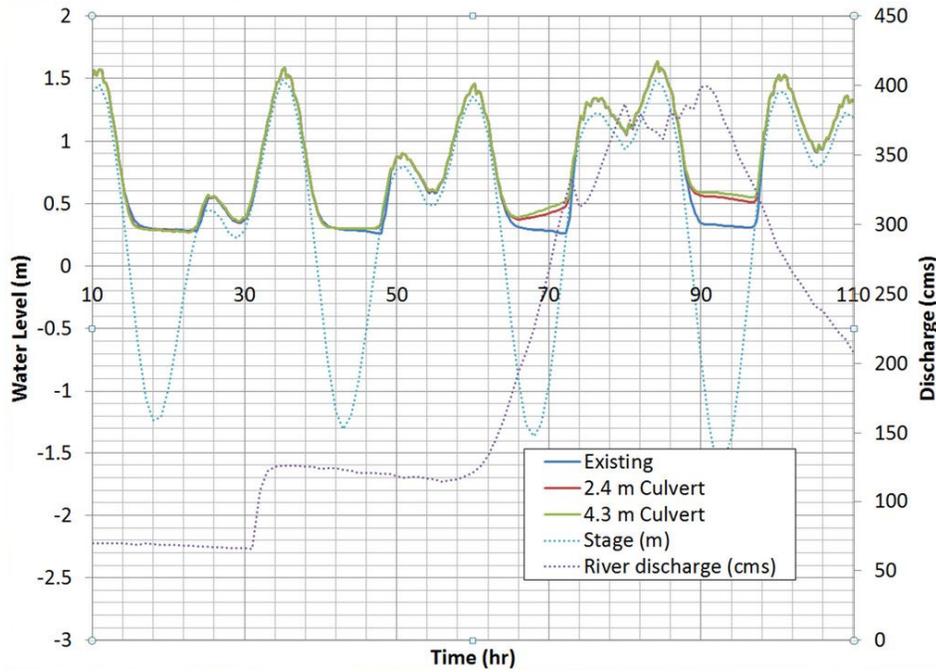
Figure 29: Comparison of water levels and discharge in lagoon with existing, 2.4 and 4.3m culvert options for proposed breach given winter baseline flows. Figure courtesy of Graham Hill of NHC.

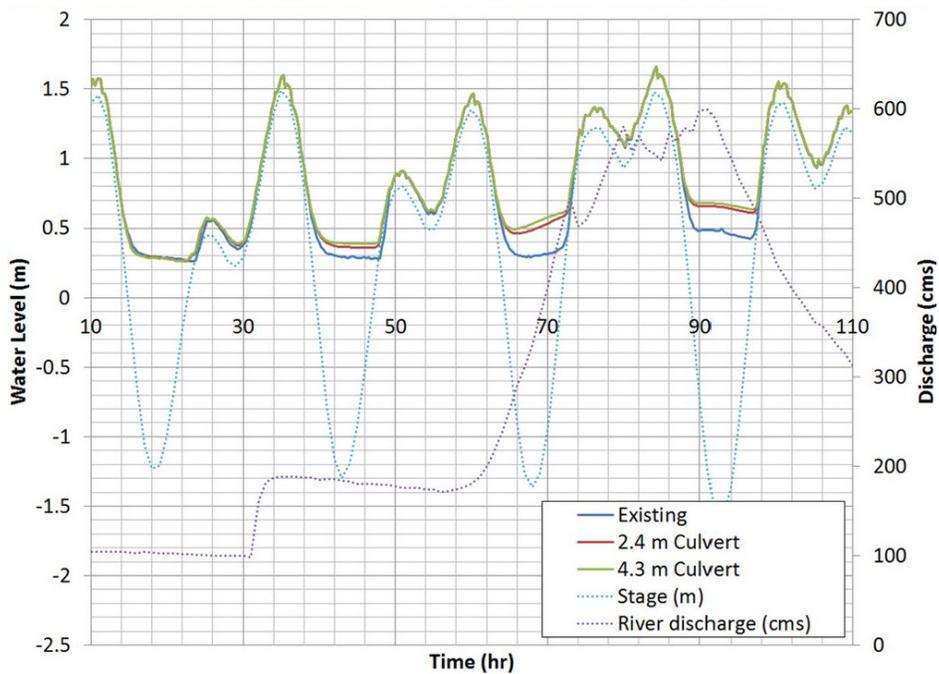
Figure 30: Comparison of water levels and discharge in lagoon with existing, 2.4 and 4.3m culvert options for proposed breach given extreme flow conditions. Figure courtesy of Graham Hill of NHC.

A comparison of winter and extreme discharge flows through the two culvert scenarios found the maximum baseline winter culvert discharge of ~0.83cms in the 4.3m culvert was approximately twice that of the 2.4m culvert. Given these discharges, issues from erosion around the culverts were considered minimal by the engineer. Water levels differences were not large between the two culvert scenarios or from existing conditions: the maximum water level increase over existing conditions that could be expected during extreme flood conditions (river discharge 400cms) with either culvert size was approximately 30cm during a low tide, and no difference during a high tide (Figure 30).
